UNDERWATER BRIDGE INSPECTION REPORT

STRUCTURE NO. 7003

BIG FORK RIVER

DISTRICT 1 - ITASCA COUNTY

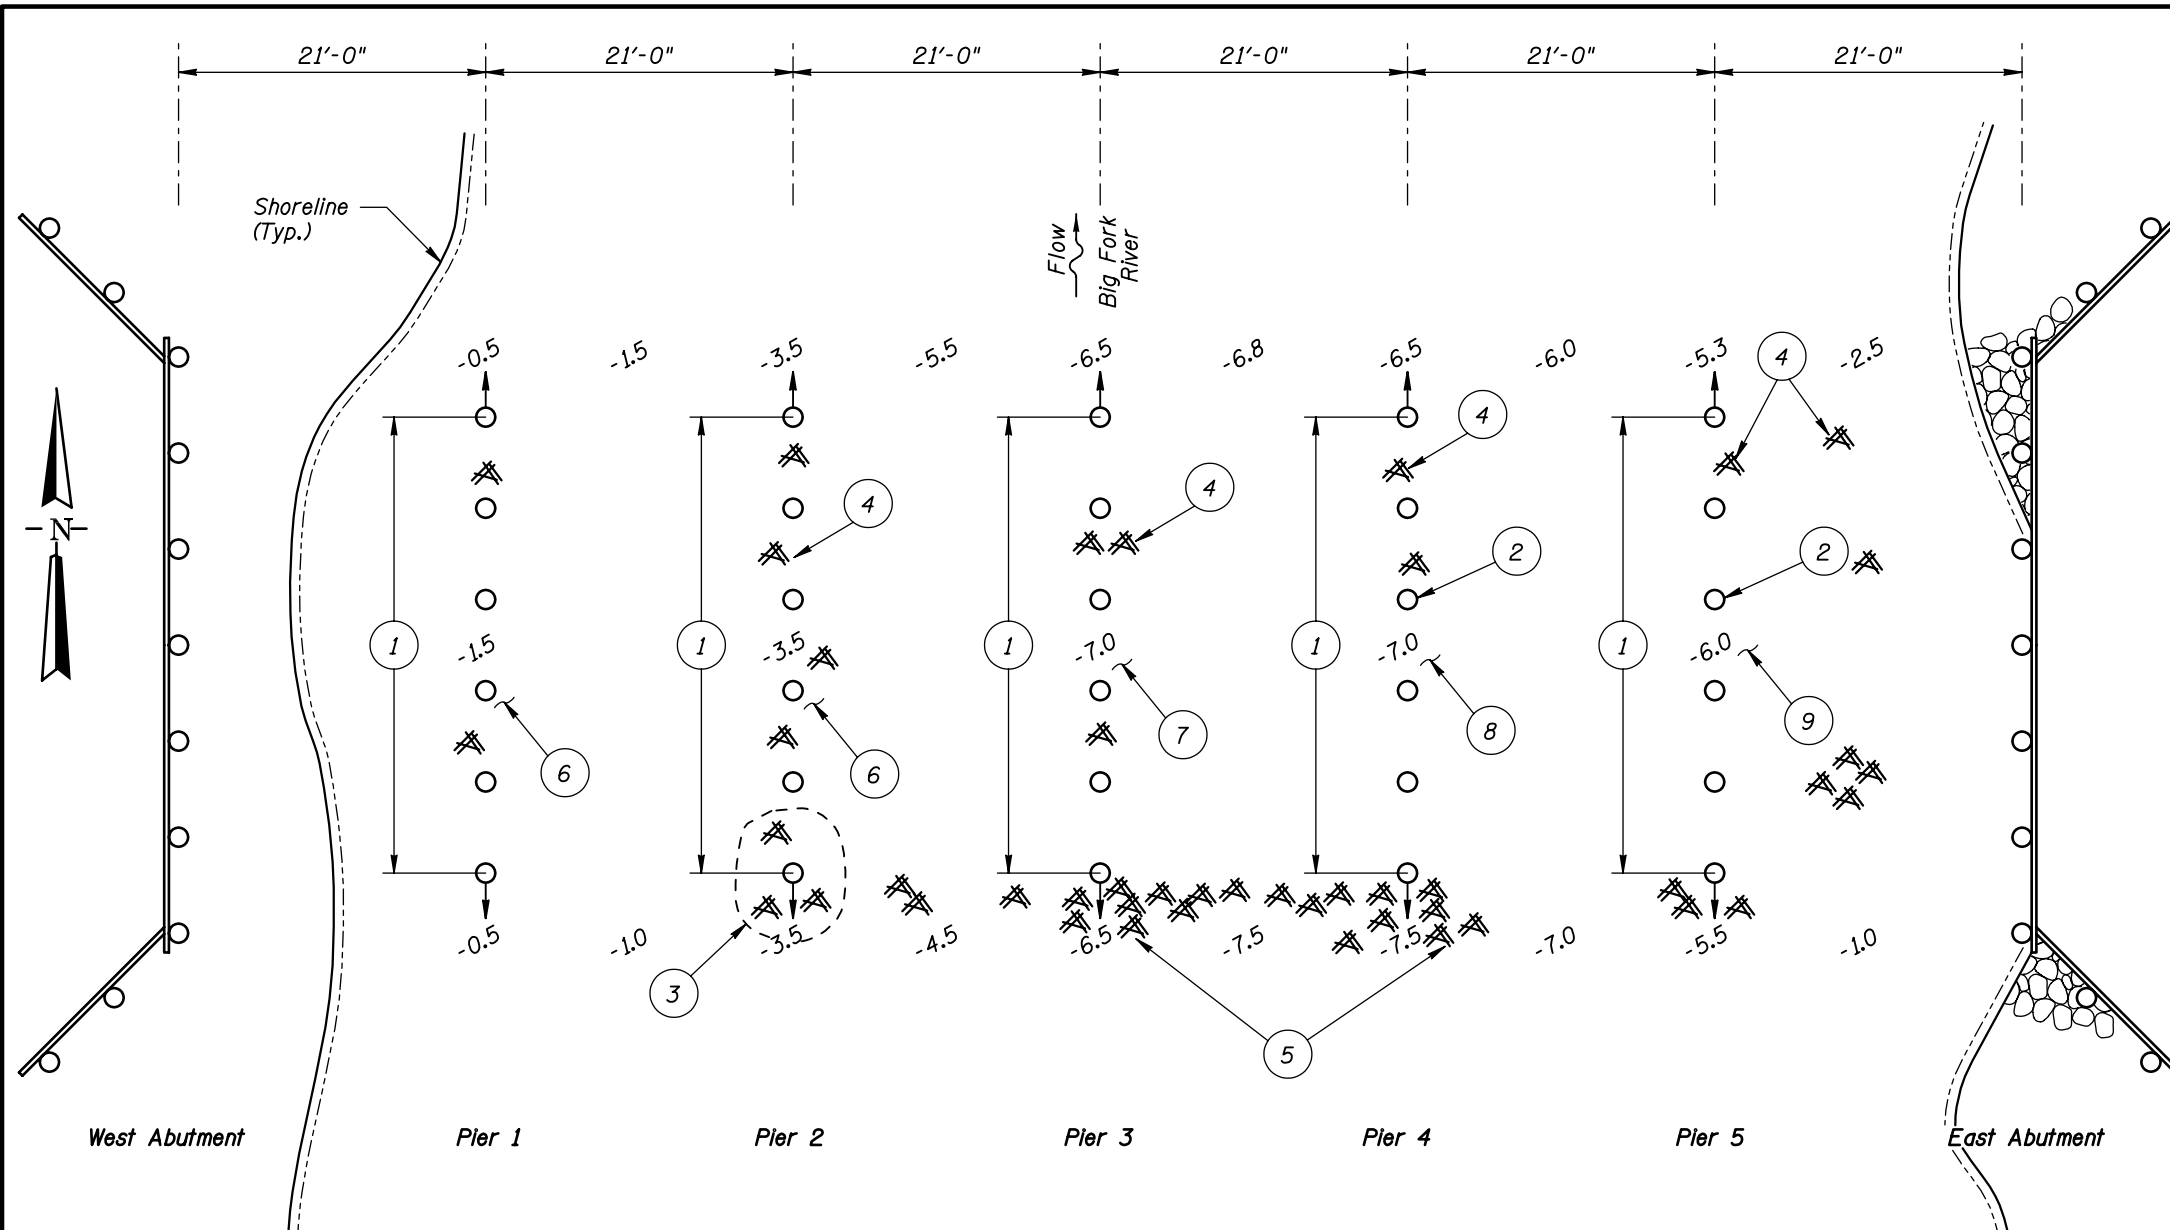
SOUNDING PLAN

- 1 Overall, the timber piles were firm and sound with random checking typically 1/8-inch-wide and 1- to 3-foot-long.
- 2 Pile exhibited a 1/4-inch-wide, 3-inch-deep split extending from the top of the pile to the mudline.

- 3 A 3-foot-radius, 2-foot-deep scour pocket was observed at the upstream pile at Pier 2.
- 4 Random 6- to 18-inch-diameter pieces of timber debris were scattered on the channel bottom throughout the pier.

- 5 A moderate accumulation of timber debris was observed along the upstream fascia extending from 1 foot above the waterline to 1 foot below the waterline at Piers 3 and 4 and the span in between and from the channel bottom to the waterline at Pier 5.

- 6 The channel bottom consisted of silt with probe rod penetrations ranging from 1 to 2 feet along Pier 2 to 2 to 3 feet along Pier 1.
- 7 The channel bottom consisted of silty sand with a probe rod penetration of 6 inches.

- 8 The channel bottom consisted of sandy gravel with 3 inches of probe rod penetration.
- 9 The channel bottom consisted of sand and gravel with 1-foot-diameter cobbles with no probe rod penetration.

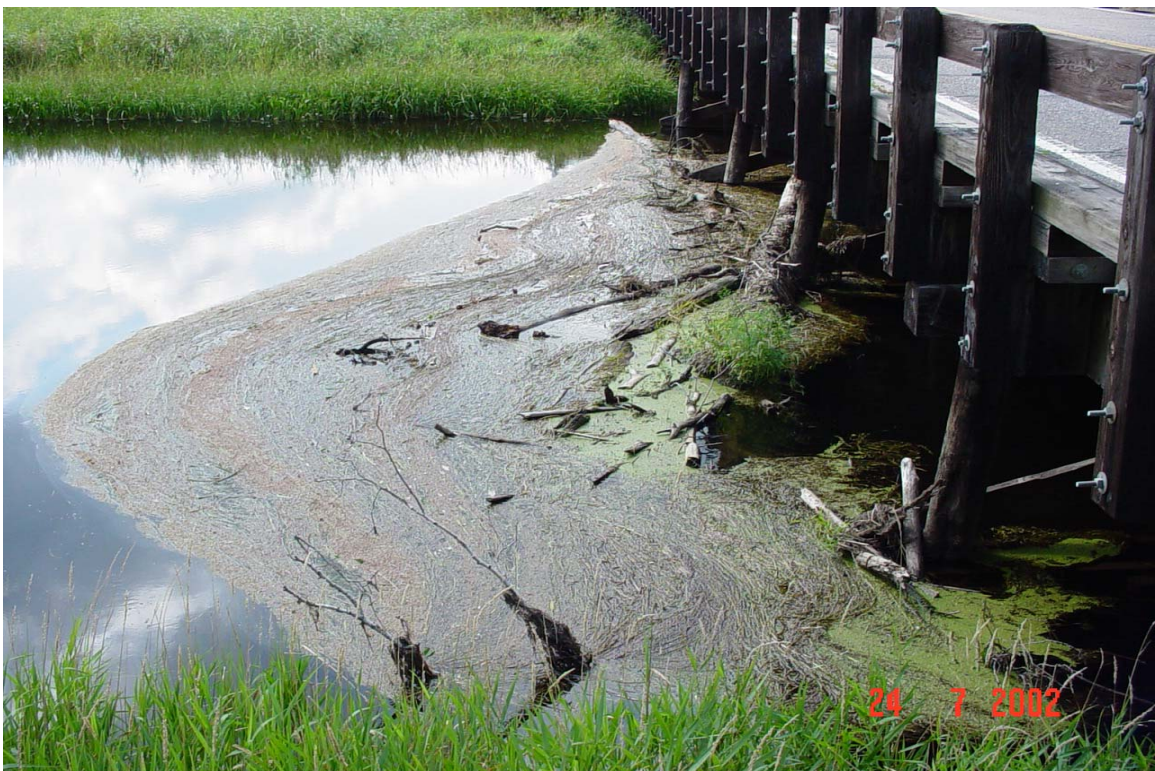
Photograph 2. View of the Timber Debris along Upstream Fascia, Looking West.

- (A) At this point, timber drift accumulation at the bridge is not excessive; however, it should be monitored, and if found to be progressing to an extent where excessive lateral loads may be exerted on the bridge or scour may be influenced, the drift may need to be removed at that time.
- (B) Reinspect the submerged substructure units at the normal maximum recommended (NBIS) interval of five (5) years.

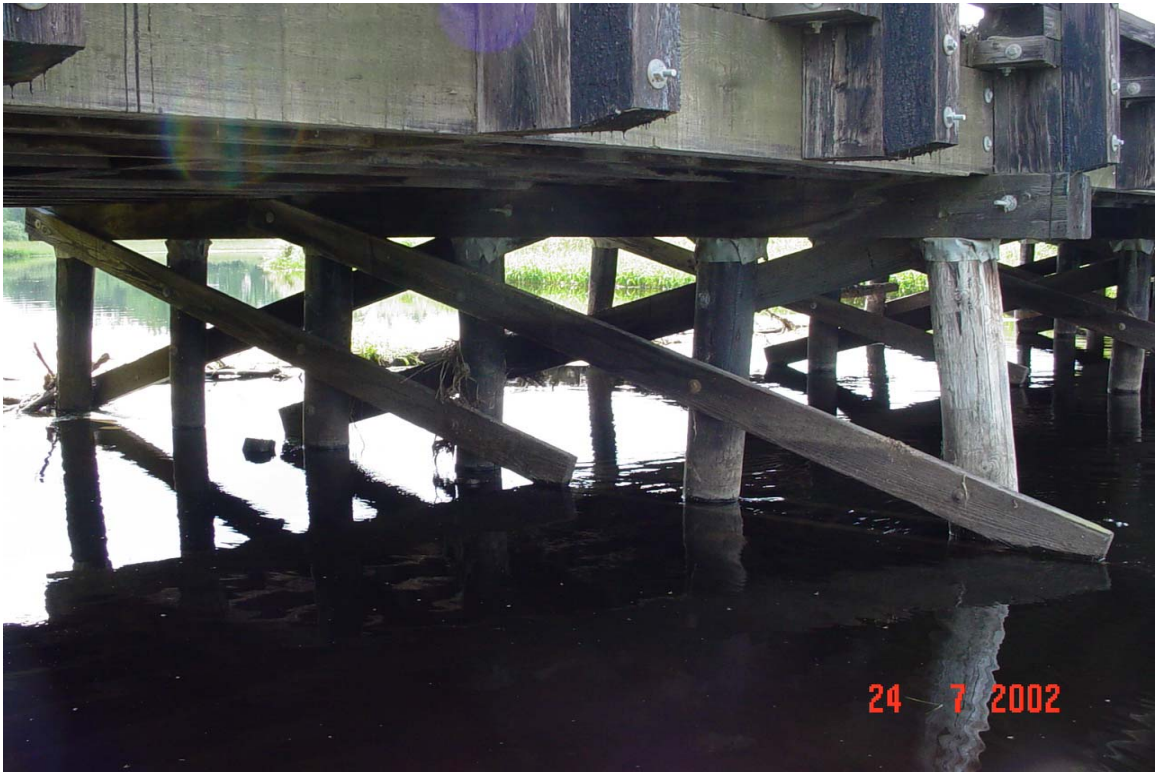
Photograph 3. View of Pier 5, Looking West. Typical Condition and Configuration of all Piers.

Reinspect the submerged substructure units at the normal maximum recommended interval of five (5) years.
